Manhole Inspection Summary

Manhole # S06YY1012MH

Location Address: **4014 CLARKS LN** Cross Street: **REISTERSTOWN RD**

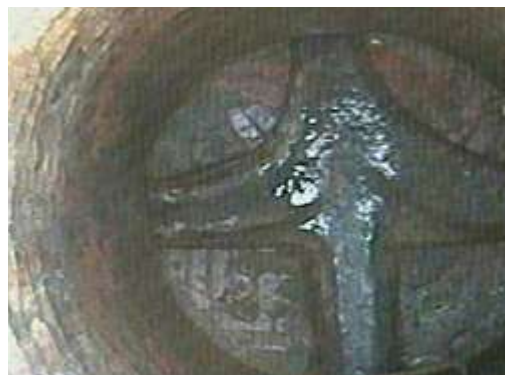
Top View

Adjustment, Corbel and Barrel infiltration.
Evidence of surcharge - Bench debris.

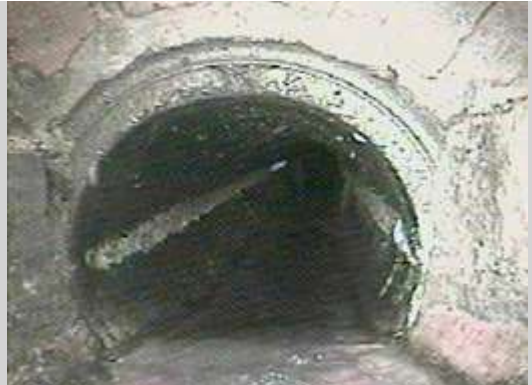
8 in. Circular Gravity Sewer Pipe Out @ 12 O'Clock

Comments **The I6 pipe seal is not flush to the pipe. The O12 pipe picture shows grease deposits inside of the pipe. Clarks Ln (alley behind). 6707 Reisterstown Rd. (behind)**

Deposits: ☐ None ☐ Mud ☐ Sludge ☐ Debris ☒ Grease

Silt Depth: **0** (in.) Deposits Extent: **Light**

Infiltration: **Evidence** Pipe Seal Cond: **Unknown**

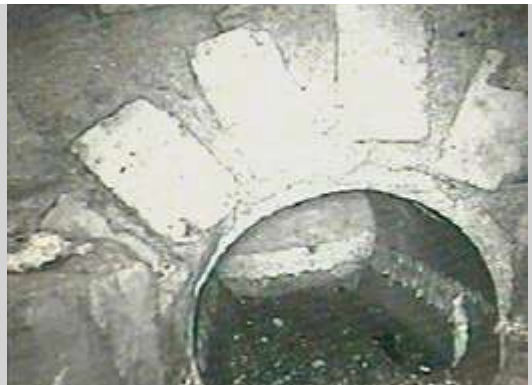
8 in. Circular Gravity Sewer Pipe In @ 3 O'Clock

Deposits: ☐ None ☐ Mud ☐ Sludge ☒ Debris ☒ Grease

Silt Depth: **1** (in.) Deposits Extent: **Light**

Infiltration: **Evidence** Pipe Seal Cond: **Unknown**

Connects To: **Stub connection / abandoned**

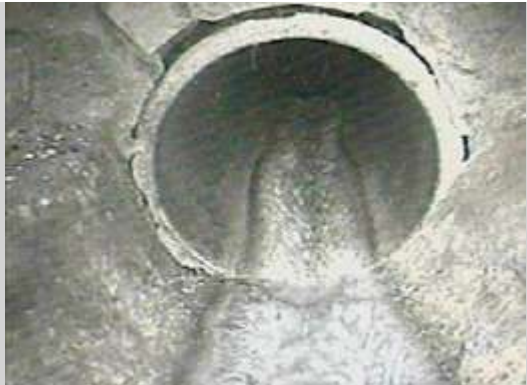
Pipe In @ 6 O'Clock

Infiltration: **Evidence** Pipe Seal Cond: **Unknown**

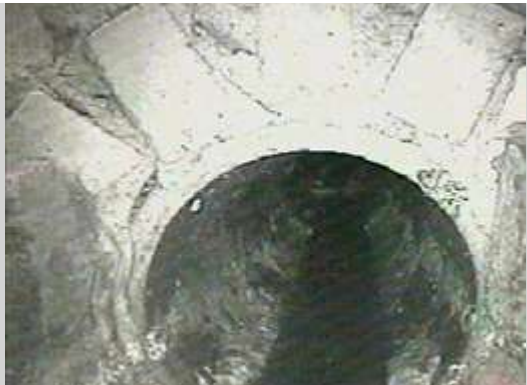
Pipe In @ 9 O'Clock

Deposits: ☐ None ☐ Mud ☐ Sludge ☐ Debris ☒ Grease

Silt Depth: **0** (in.) Deposits Extent: **Light**

Infiltration: **Evidence** Pipe Seal Cond: **Roots**
